NPDES Compliance Inspection Report

Mapleville Dairy Inc.
Sumas, Washington
February 2, 2011

Prepared by:
Kristin McNeill
Environmental Scientist
U. S. Environmental Protection Agency, Region 10
Office of Compliance and Enforcement
Inspection and Enforcement Management Unit

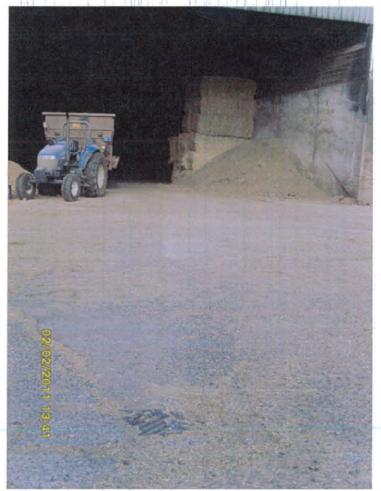
As was discussed in the Feed Storage Area section, there is a storm drain near the feed storage bunkers at the main dairy. Although the drain is near the silage storage area, the concrete is sloped away from the drain to avoid potential runoff of silage leachate. However, the drain is approximately 10 yards from the grass and hay storage bunker, where the concrete is not sloped away from the drain. At the time of inspection, there was grass and hay near the drain (photo 2). According to the DeVries, only roof and concrete slab water flows into the storm drain. John DeVries stated that he thought that the storm drain flowed into a culvert and then into Johnson Creek north of the main dairy. Steve Hulbert (WSDA) agreed to follow up with the DeVries to determine the outfall location and to ensure that feed is not allowed to enter the storm drain.

Photo 2. Storm drain approximately 10 yards from the grass and hay storage bunker.

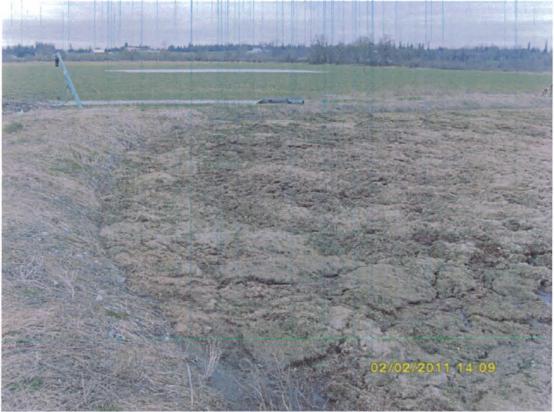
At the dry cow facility, the lagoon was 99% full and was leaking in at least two locations along the southern wall (photos 5-12). According to Dale DeVries, at the time of inspection, the lagoon had been leaking for 1-1.5 weeks. Although the DeVries had attempted to reinforce the leaking areas by piling dirt and gravel along the outside of the lagoon, the leaks had permeated through the dirt and gravel, and liquid waste was continuing to flow back into the animal confinement area. The waste was eventually

Photo 5. Lagoon at dry cow facility that was approximately 99% full with approximately 1 foot of freeboard.

During my follow up phone call on February 17, 2011, Dale stated that the Conservation District had agreed that they should land apply some of the waste to reduce the volume in the lagoon. Although the weather conditions had not yet met the threshold at which land application may normally resume in Whatcom County, the DeVries were allowed to land apply during a period of dry weather in areas far from surface water. They pumped down 2-3 feet of manure which stopped the leaks from the lagoon wall.

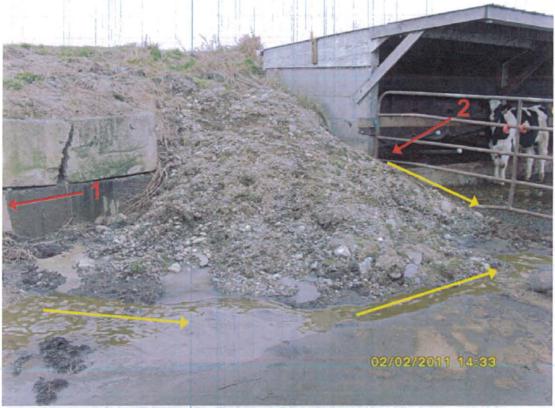
The DeVries suggested that the leaks had originated from rat holes in the top part of the berm. They had pumped waste from their upright tank at the main dairy into the lagoon approximately 0.5-1 week before the leaks began. At the time of inspection, the DeVries had not yet contacted anyone at WSDA or the Whatcom Conservation District to notify them about the lagoon leaks. Joe Roberto suggested that they notify the proper agency, and Dale DeVries contacted Bill Bonsen at the Conservation District before we completed the inspection. Bill Bonsen agreed to send someone from the Conservation District the following day to inspect the lagoon and determine the proper course of action.

Photo 6. Dirt and gravel placed along the lagoon wall to attempt to stop the leaks at the dry cow facility. Red arrows indicate leak locations and yellow arrows indicate flow direction at the time of inspection.

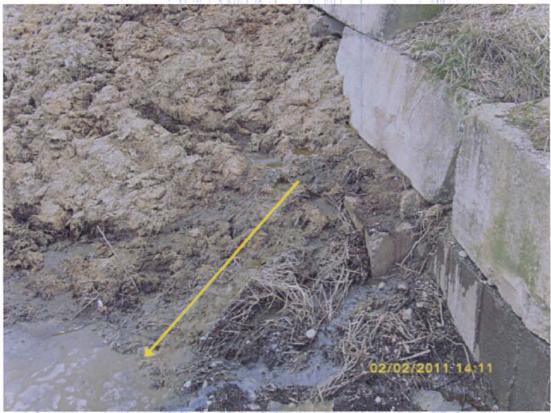
Photo 7. Flow of first lagoon leak (yellow arrow indicates flow direction).

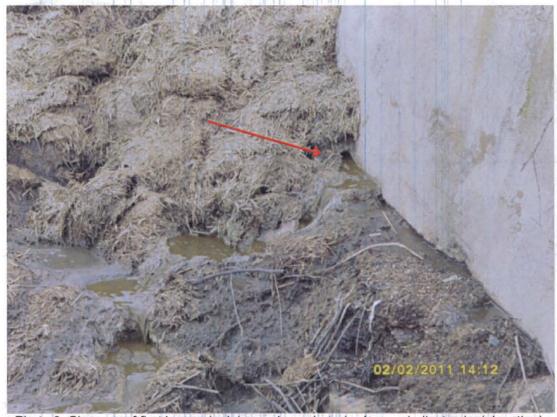
Photo 8. Close up of first lagoon leak in previous photo (red arrow indicates leak location).

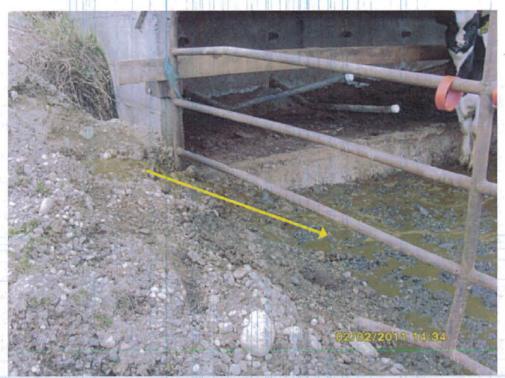
Photo 9. Second lagoon leak at dry cow facility (yellow arrow indicates flow direction).

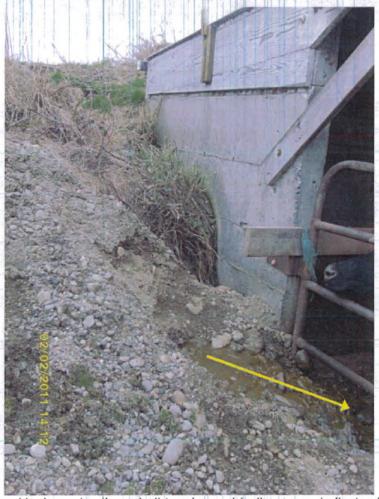
Photo 10. Second leak coming through dirt and gravel (yellow arrow indicates flow direction).

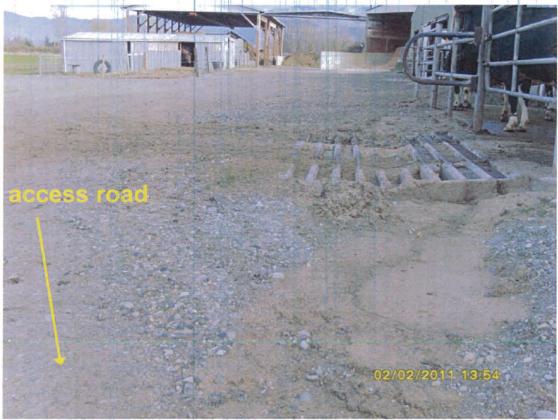
At the time of inspection, at the northwest corner of the main dairy, there was evidence that manure had run out of the barn entrance on a previous occasion (photo 13). Manure track out from vehicles was also visible outside the barn entrance. Outside the barn entrance, the ground is slightly sloped toward an adjacent access road and Johnson Creek. Johnson Creek is approximately 25 yards from the barn entrance (photo 14). At the time of inspection, manure did not appear to have crossed the access road or entered Johnson Creek. Although the DeVries did not identify this location as an area of potential discharge, Steve Hulbert suggested that they may want to add a berm to that section of the creek bank to prevent any potential discharges.

Photo 13. East view of entrance on the northwest corner of the barn where manure track out and previous manure flow are evident.

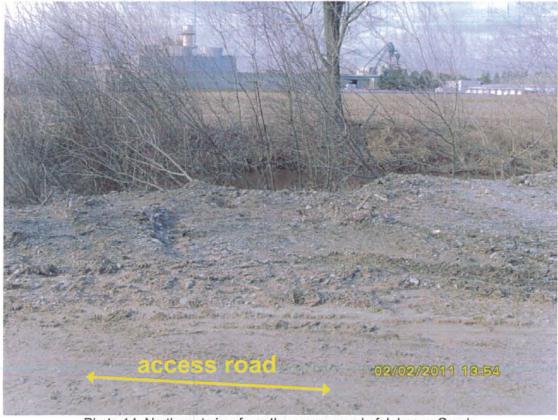
Photo 14. Northwest view from the access road of Johnson Creek, approximately 25 yards from the northwest entrance of the barn.
